PARSONS ENGINEERING SCIENCE, INC.

July 11, 1996

Subject: Results of Additional Bioventing Respiration Testing at Sites ST61, ST71, and ST43/55 (Pumphouse III and Valve Pit 3-4), performed under Contract No. F41624-92-8036, Order 17.

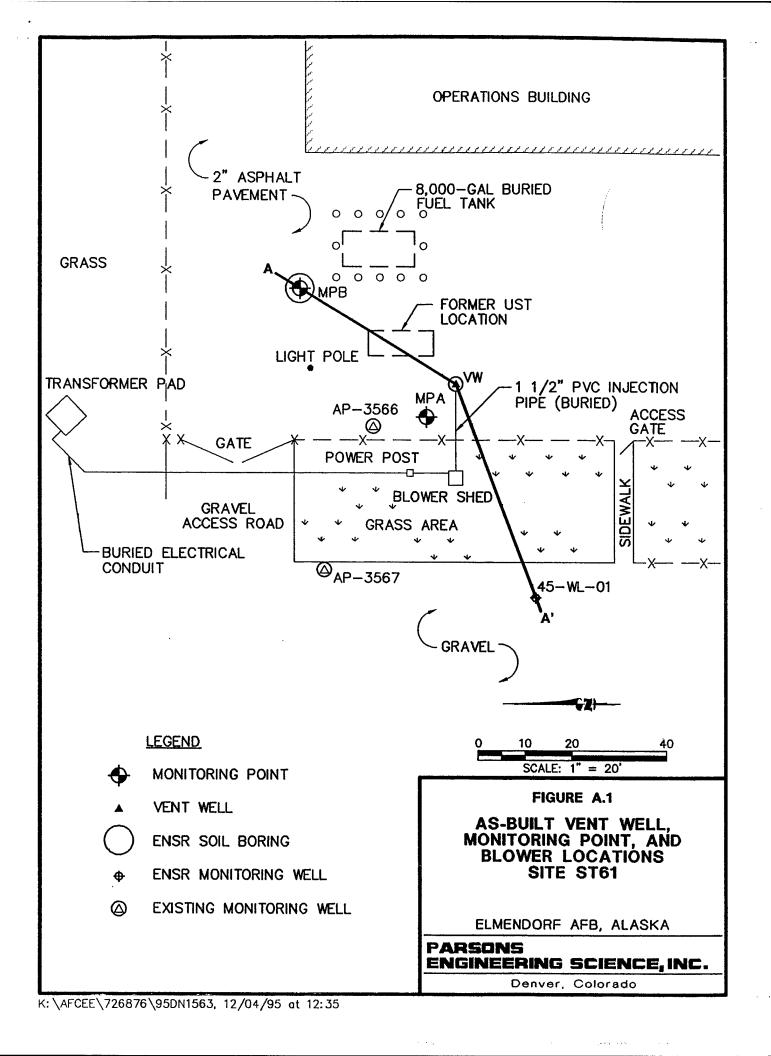
## ATTACHMENT A SITE ST61

Site ST61, currently the location of a Navy operations facility, was formerly a vehicle maintenance facility (Attachment A, Figure A.1). Wastes generated at the site may have included waste oil, solvents, paints, and fuels. Details of site conditions and the initial pilot test are contained in the Pilot Test Interim Results Report (ES, 1993).

During the period of May 23-28, 1996, an *in situ* respiration test was performed to determine the continued rates of oxygen utilization at the site. Results of each *in situ* respiration test conducted to date, and the corresponding hydrocarbon degradation rates are summarized in Table A.1. Respiration rates in May 1996 at contaminated monitoring points ranged from 0.0008 to 0.0054 percent oxygen utilized per minute (%/min). The corresponding biodegradation rates ranged from 170 to 650 milligrams of fuel per kilogram of soil per year (mg/kg/year). Based on the results of this test, a significant amount of fuel residuals still remains in soils at this site, and biodegradation of these residuals is still occurring at significant rates. The lowest rate of oxygen utilization was measured at the vent well (0.0008 %/min). This is consistent with past measurements and is indicative of the relatively low level of hydrocarbon contamination initially measured at the vent well. MPA-4 (Figure A.1) exhibited the greatest oxygen demand,

indicating that significant biodegradation of fuel residuals is occurring. Based on the 1-year soil sampling results, high concentrations of fuel hydrocarbons still existed at this location.

Because of the low-permeability soils at this site, short circuiting of the injected air has been observed in the past. Following system startup on May 28, 1996 water was sprayed on the asphalt near the VW to see if air was still short circuiting, and short circuiting was not observed (air bubbles at the asphalt surface). Navy personnel at Classic Owl (Building 52-140) stated that they had not noticed any air bubbles in the past year. Oxygen influence measurements at MPA confirmed that oxygen influence is still being delivered to soils within the area of contamination.

Although limited data is available for Site ST61, it is expected that the system at ST61 is providing full-scale treatment of impacted soils. Because significant oxygen utilization was observed at this site, particularly at MPA-4, continued operation is recommended. Annual respiration tests should continue, and soil sampling should be performed after oxygen utilization rates approach background rates. The short circuiting problem that was observed in the past appears to have subsided. It is possible that preferential subsurface air pathways have been developed over the past two years, thus allowing less air flow to the surface.

Since monitoring well AP-3566 (which was used as an MP) was abandoned recently it is recommended that an additional MP be installed near the former location of well AP-3566 or immediately south of the blower shed at Site ST61. Since the blower shed is located in a grassy area it may not be desirable to drive a heavy drill rig over the grass. An additional MP would also provide more soil analytical data that may further characterize the current site conditions.

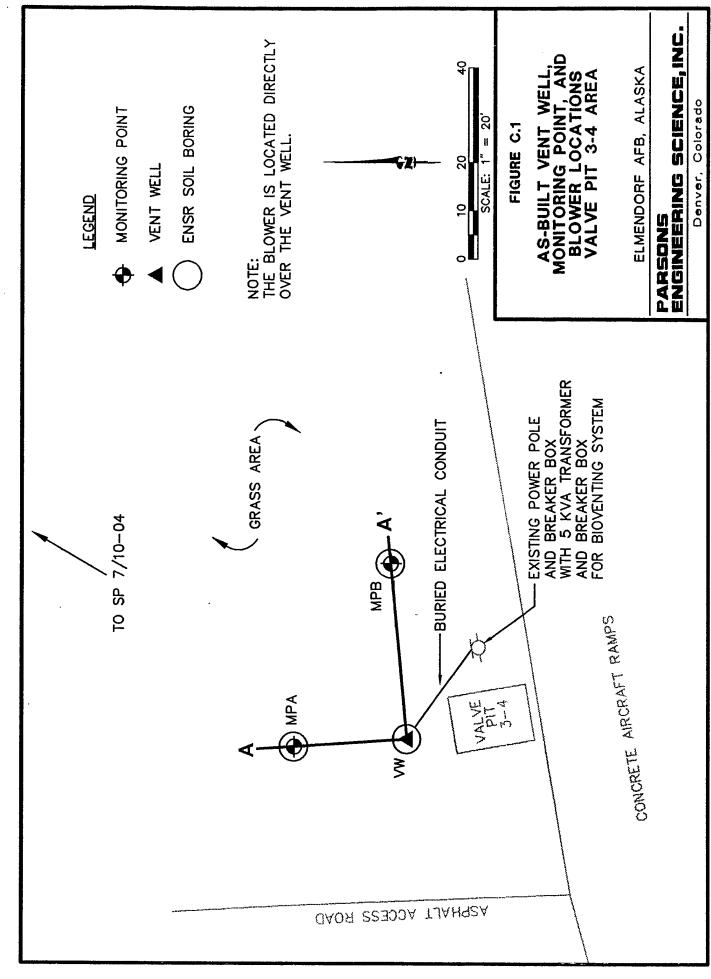
# ATTACHMENT C SITE ST43/55 - VALVE PIT 3-4

Site ST43/55-Valve Pit 3-4, is located east of Pumphouse III (Building 42-103) and immediately north of Valve Pit 3-4 (Attachment C, Figure C.1). Details of site conditions and the initial pilot test are contained in the Pilot Test Interim Results Report (ES, 1993).

During the period of May 23-28, 1996, an *in situ* respiration test was performed to determine the continued rates of oxygen utilization at the site. Results of each *in situ* respiration test conducted to date, and the corresponding hydrocarbon degradation rates are summarized in Table C.1. Respiration rates at contaminated monitoring points ranged from 0.00021 to 0.0026 %/min and biodegradation rates ranged from 60 to 760 mg/kg/year. Based on the results of this test, a significant amount of fuel residuals remains in soils at this site, and biodegradation of these residuals is occurring at significant rates. Although not completely comparable, significantly lower rates of oxygen utilization were measured at the VW and MPB as compared to the initial, 1-year,

and 2-year "point" respiration test results. This decreasing trend is consistent with observations made at many other bioventing sites, as discussed above.

Bioventing systems at the Pumphouse III and Valve Pit 3-4 sites are treating only a portion of larger contaminated soil volumes. Continued operation will continue to

facilitate biodegradation of fuel hydrocarbons within the treatment area or transported into the treatment area. However, treatment of the entire contaminated soil volume will require installation of full-scale systems. Based on results from testing at Pumphouse III, the estimated radius of oxygen influence at Site ST43/55 is 60 feet. A review of existing data from the Final Corrective Action Plan (ENSR, 1995) indicates that a 2.5 to 5 foot thickness of soil contamination is present above the groundwater table throughout the site. Considering such, it is recommended that additional VWs and MPs be installed at the site. Limited data is available to ascertain an optimal remedial action for the entire site, however, a conceptual bioventing remedial design for the area near both existing systems is included in Attachment B (Figure B.2). The recommended VW screened intervals are also included on Figure B.2. Ideally, three additional VWs could be plumbed to the blower at Valve Pit 3-4, and two more VWs could be plumbed to the Pumphouse III blower. Flow rates should range from 10-15 standard cubic feet per minute (scfm). Additionally, it is important to monitor soil gas in areas where the radii of oxygen influence intersect. Soil gas in these areas may become stagnant due to air pressure from opposite directions. Discrete vapor MPs should be screened near the water table (approximately 16.5-20 feet below ground surface). Converting the recommended soil borings to MPs should also be considered.

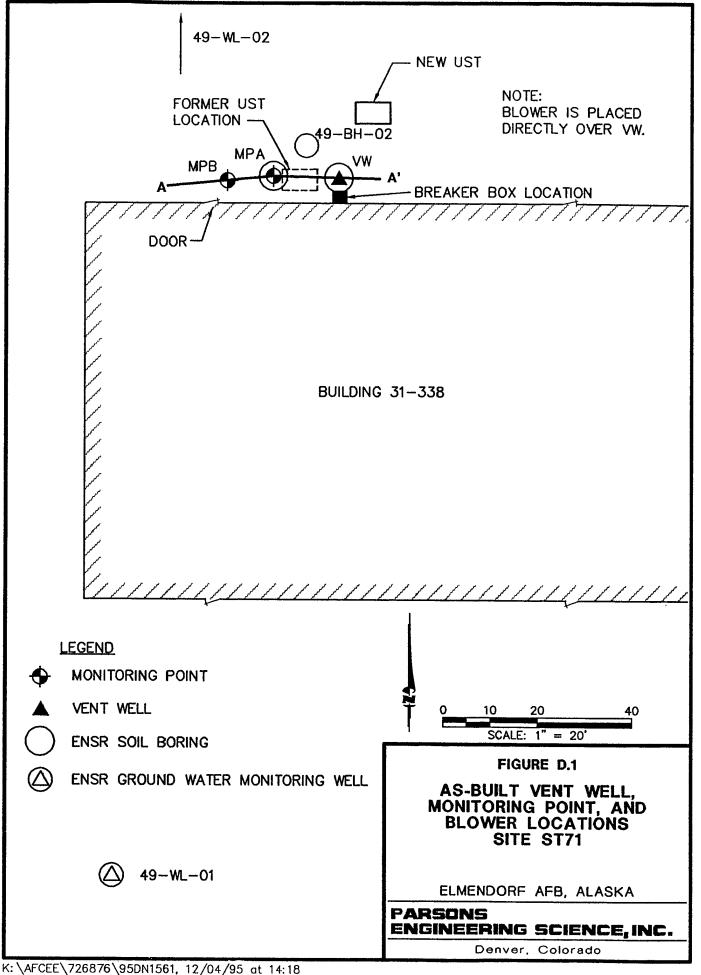
## ATTACHMENT D SITE ST71

Site ST71, currently the location of the vehicle maintenance shop building (31-338), is the location of a former 500-gallon underground storage tank (UST) that was used to store primarily diesel and JP-4 fuels (Attachment D, Figure D.1). Details of site conditions and the initial pilot test are contained in the Pilot Test Interim Results Report (ES, 1993).

During the period of May 24-28, 1996, an *in situ* respiration test was performed to determine the continued rates of oxygen utilization at the site. Results of each *in situ* respiration test conducted to date, and the corresponding hydrocarbon degradation rates are summarized in Table D.1. Respiration rates at MPB-4 and MPB-10 ranged from 0.00006 to 0.00016 %/min, respectively. The corresponding biodegradation rates ranged from 20 to 45 mg/kg/year. Based on the results of this test, minimal amounts of fuel remain in soils at this site, and biodegradation of these residuals was occurring at extremely slow rates, prior to system shut-down and closure soil sampling.
